# CASE STUDY

# Linear Heat Detection (LHD) solution for conveyor belts at cement production facility

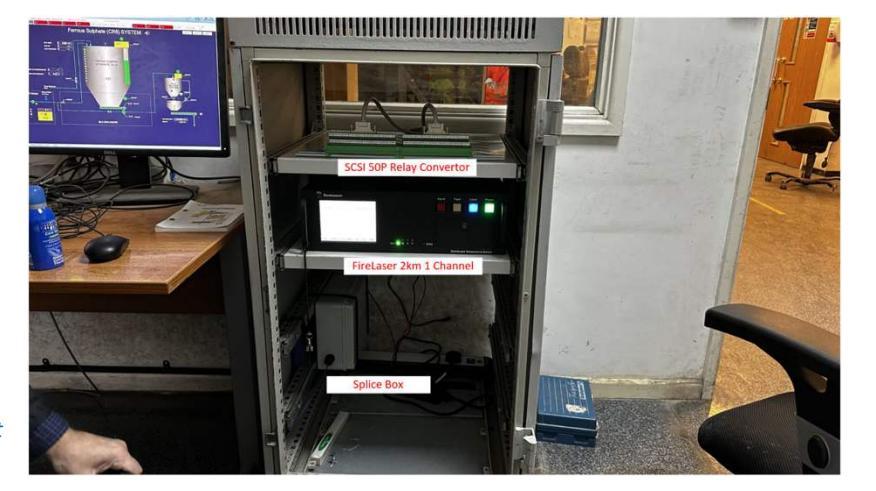
The FireLaser control unit was placed in a nearby rack cabinet for easy access. It operates independently, not connected to any computer or the customer's network during monitoring. Bandweaver personnel were informed that, for now, only the FireLaser relay output would integrate with the customer's PLC.

Figure 1: FireLaser cabinet

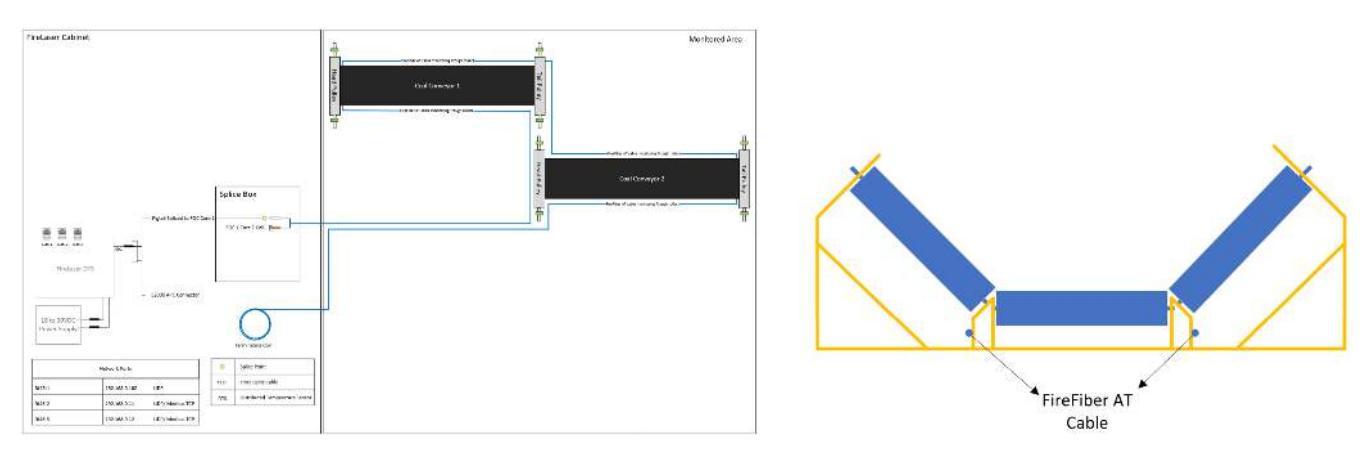
The FireFiber AT cable was configured with FireLaser's single-channel model. Rather than utilise a redundant loop, the cable was physically looped along either side of the conveyor, covering the trough rollers on the conveyor's top side. Positioned close to the trough roller bearing, the cable installation is shown below.

#### Figure 2: FireFiber AT cable layout along conveyor

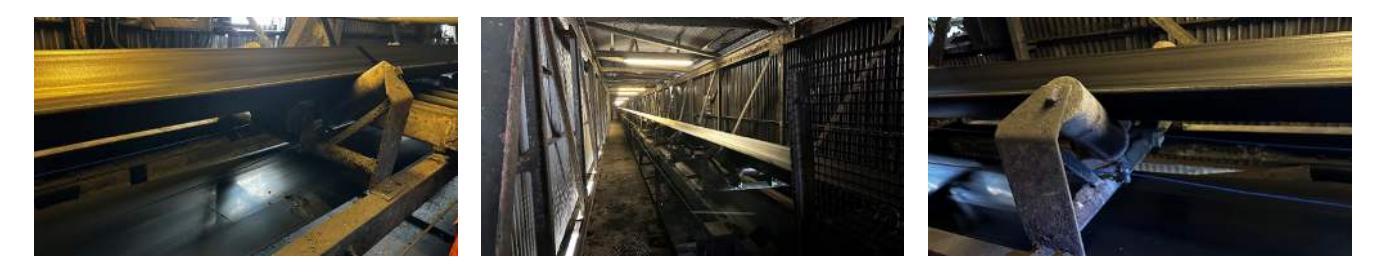
#### Figure 3: FireFiber AT cable monitoring trough rollers

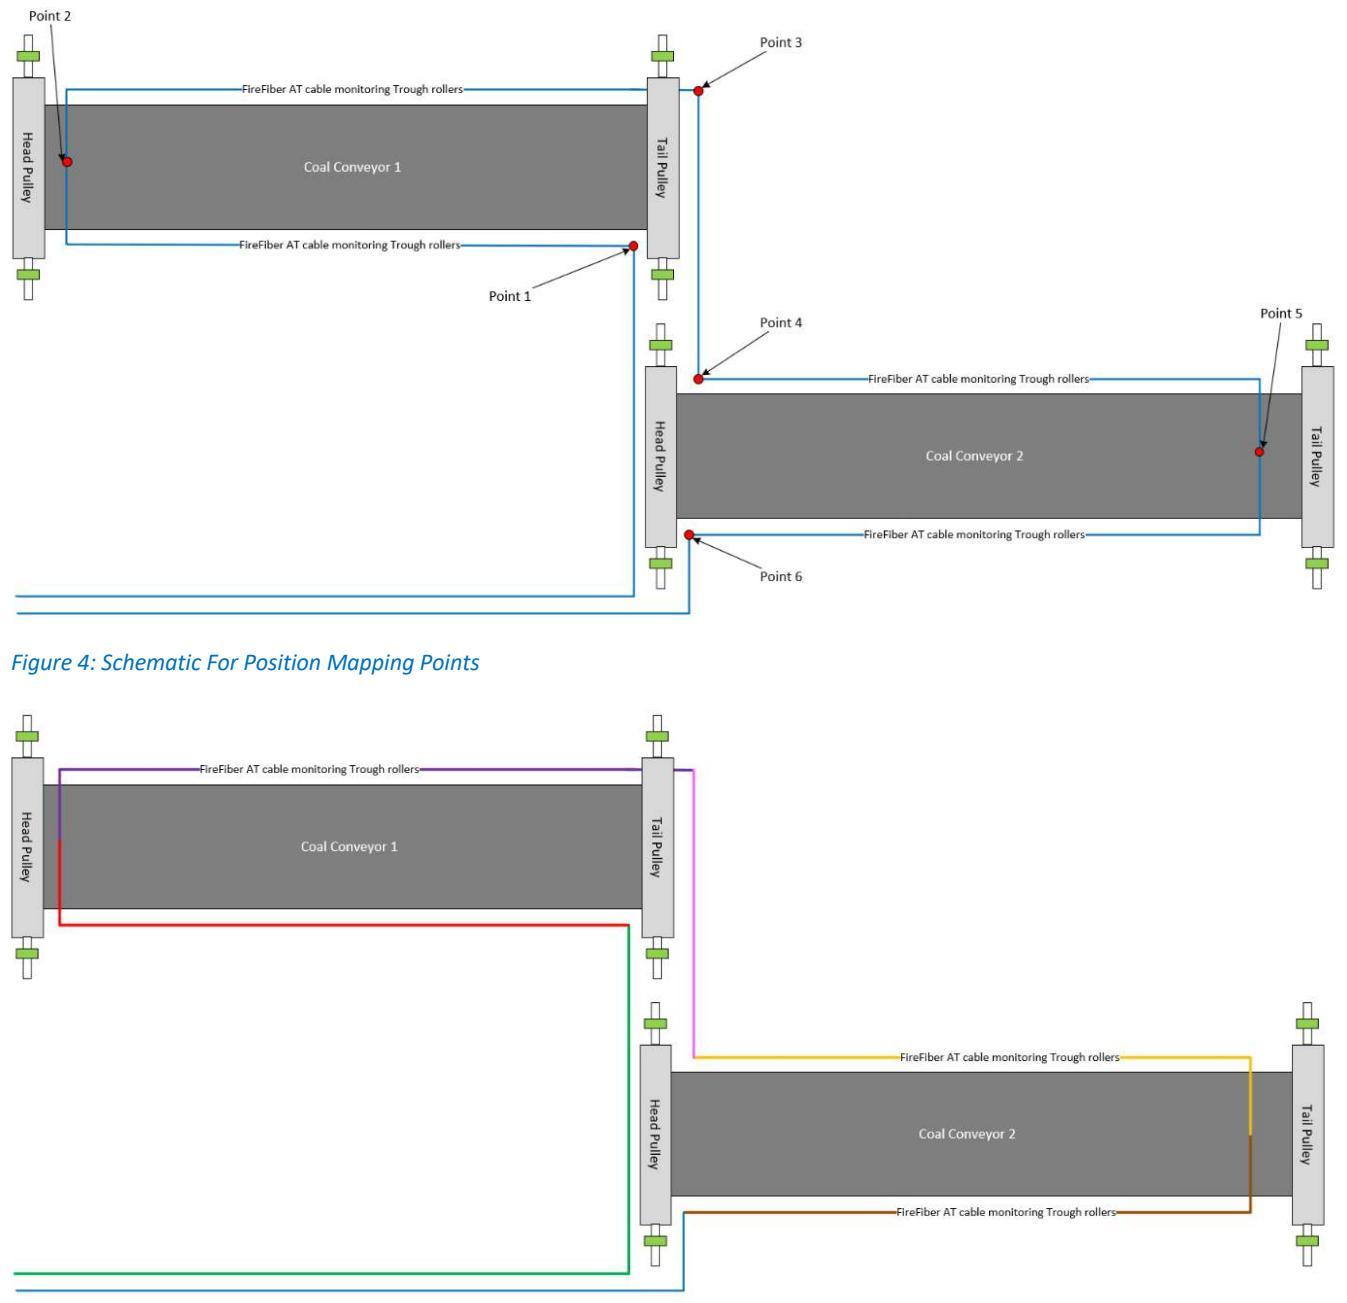
The team then did position mapping for the cable on the conveyor belt, zone division for the cable followed. The schematics below demonstrate the installation of the FireFiber AT cable on the conveyor:

#### Figure 5: Schematic For Zone Division
